## Thorax artifacts in CT – air embolism or other causes?

Int. J. Radiat. Res., July 2021;  
19(3): 653-659

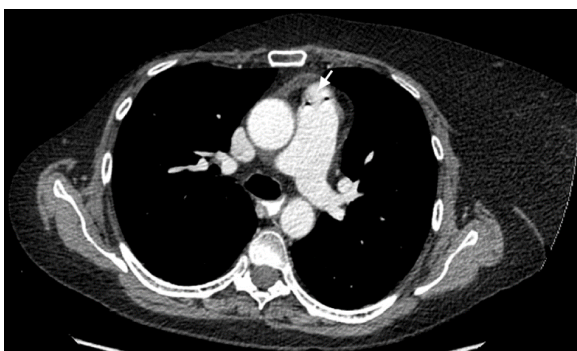
**Figure 3.** Axial image of thorax CT with contrast agent of an overweight patient, which indicates an artifact with air density in the pulmonary trunk (not in the highest level). The body of the patient was not entirely in the FOV and the artifact may have been caused by a fault of the reference detectors.

or in overweight patients where the FOV is not large enough to cover the entire part of the body. In those cases, the reference detectors measure incorrectly and produce artifacts. Further, this artifact was also observed in cases where a small amount of contrast agent was shed on the examination table of the CT scanner after vein rupture during contrast injection (figure 3).
