Thorax artifacts in CT – air embolism or other causes?

Int. J. Radiat. Res., July 2021;
19(3): 653-659

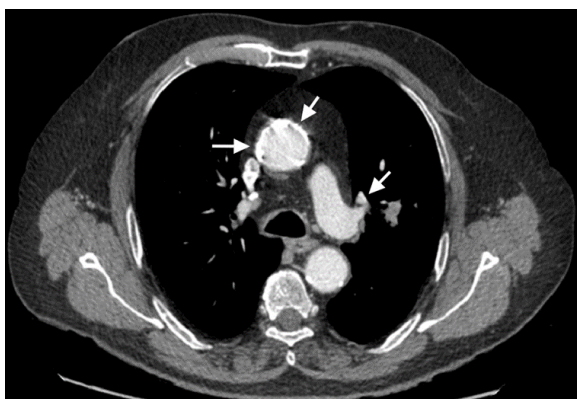
Figure 2. Axial image of thorax CT with contrast agent, which shows a streak artifact caused by the wall calcifications of the ascending thoracic aorta.

More specifically, figure 1 illustrates an artifact with air density in the pulmonary trunk that imitates vessel rupture and a streak artifact in the ascending aorta from the high contrast density in the adjacent superior vena cava. Figure 2 shows a streak artifact caused by the wall calcifications of the ascending thoracic aorta. In figure 3, an artifact with air density in the pulmonary trunk is presented. In this case, the body of the patient was not entirely in the FOV. Figure 4 illustrate four artifacts with air density (in the cardiac muscle and on the top of the pulmonary vessels), which occurred in a case that no contrast agent was used. Finally, figure 4 demonstrates artifacts with air densities in the middle of the pulmonary vessels with the shape of undefined lines.

The present study proves that the causes of all the aforementioned artifacts are numerous. In fact, their most frequent form are streak artifacts. Although, the most common cause of those artifacts is the existence of metallic implants in the patient, there are other reasons too. For example, sometimes contrast agent may have so high density that mimics metal, so it creates streak artifacts especially near superior vena cava (figure 1) (7, 10-12, 14, 22-24). Also, more rarely, even wall calcifications of the thoracic vessels could mimic metal densities and create streak artifacts (figure 2).

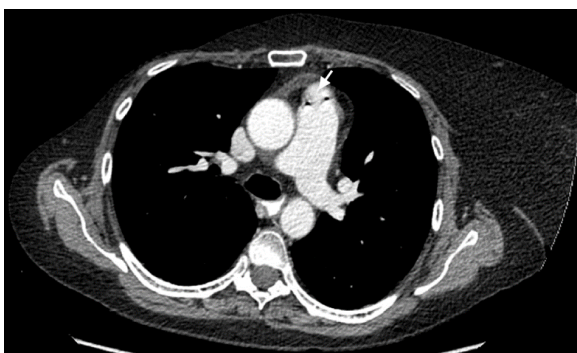
Figure 3. Axial image of thorax CT with contrast agent of an overweighted patient, which indicates an artifact with air density in the pulmonary trunk (not in the highest level). The body of the patient was not entirely in the FOV and the artifact may have been caused by a fault of the reference detectors.

or in overweight patients where the FOV is not large enough to cover the entire part of the body. In those cases, the reference detectors measure incorrectly and produce artifacts. Further, this artifact was also observed in cases where a small amount of contrast agent was shed on the examination table of the CT scanner after vein rupture during contrast injection (figure 3).

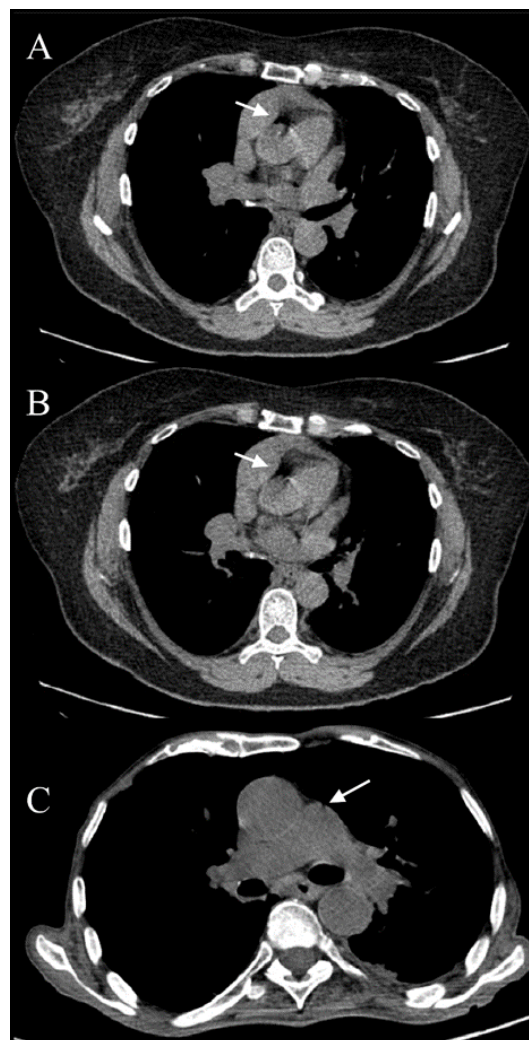
Figure 4. A-C. Axial images of thorax CT without contrast injection. Images (A) and (B) depict an artifact with air density in the cardiac muscle. Image (C) shows a small artifact with air density on the top of the pulmonary vessels. These artifacts may occur due to respiratory movements during scanning.

However, these artifacts are not commonly described in the literature despite their frequent appearance as air existence. In the present study, those artifacts were observed not only in cases involving contrast injection, but also in simple scans where no contrast was used. In those contrast agent-free scans, artifacts were caused by respiratory movements (figure 4).

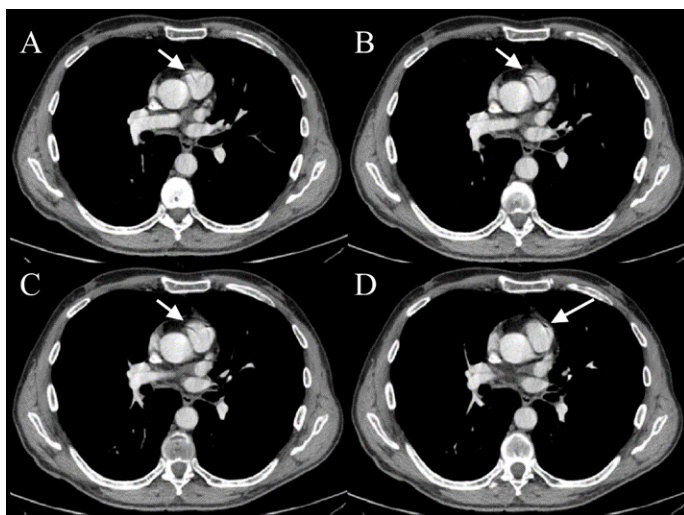
Figure 5. A-D. Axial consecutive images of thorax CT, which illustrate artifacts with air densities in the middle of the pulmonary vessels with the shape of undefined lines and they may be due to the existence of contrast agent on the examination table of the CT scanner.

Normally, every amount of air accumulates in the upper part of the anatomic structures. However, in this study, in some cases those artifacts appeared in the middle or lower sections of vessels in the form of lines and other long shapes. These findings indicate that those artifacts were not caused by the existence of air but instead due to the existence of an amount of contrast agent on the examination table of the CT scanner (figure 5).
