Thorax artifacts in CT – air embolism or other causes?

Int. J. Radiat. Res., July 2021;
19(3): 653-659

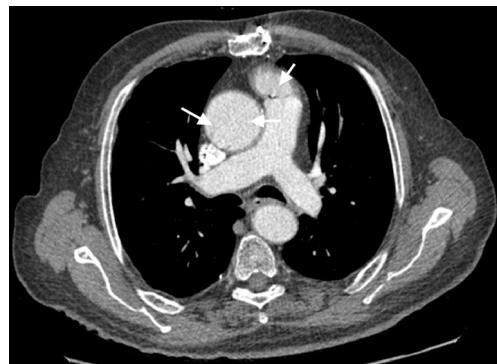
Figure 1. Axial image of thorax CT with contrast agent, which demonstrates an artifact with air density in the pulmonary trunk that imitates vessel rupture. This may have occurred from a false response of the reference detectors due to the existence of a small amount of contrast agent on the examination table of the CT scanner (upper right arrow). In addition, a streak artifact is present in the ascending aorta from the high contrast density in the adjacent superior vena cava.

More specifically, figure 1 illustrates an artifact with air density in the pulmonary trunk that imitates vessel rupture and a streak artifact in the ascending aorta from the high contrast density in the adjacent superior vena cava. Figure 2 shows a streak artifact caused by the wall calcifications of the ascending thoracic aorta. In figure 3, an artifact with air density in the pulmonary trunk is presented. In this case, the body of the patient was not entirely in the FOV. Figure 4 illustrate four artifacts with air density (in the cardiac muscle and on the top of the pulmonary vessels), which occurred in a case that no contrast agent was used. Finally, figure 4 demonstrates artifacts with air densities in the middle of the pulmonary vessels with the shape of undefined lines.

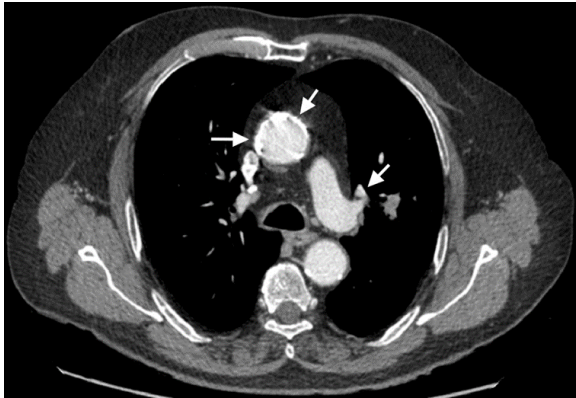
Figure 2. Axial image of thorax CT with contrast agent, which shows a streak artifact caused by the wall calcifications of the ascending thoracic aorta.

The present study proves that the causes of all the aforementioned artifacts are numerous. In fact, their most frequent form are streak artifacts. Although, the most common cause of those artifacts is the existence of metallic implants in the patient, there are other reasons too. For example, sometimes contrast agent may have so high density that mimics metal, so it creates streak artifacts especially near superior vena cava (figure 1) (7, 10-12, 14, 22-24). Also, more rarely, even wall calcifications of the thoracic vessels could mimic metal densities and create streak artifacts (figure 2).

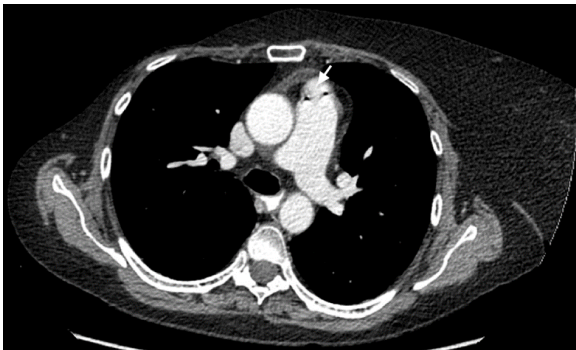
Figure 3. Axial image of thorax CT with contrast agent of an overweight patient, which indicates an artifact with air density in the pulmonary trunk (not in the highest level). The body of the patient was not entirely in the FOV and the artifact may have been caused by a fault of the reference detectors.

or in overweight patients where the FOV is not large enough to cover the entire part of the body. In those cases, the reference detectors measure incorrectly and produce artifacts. Further, this artifact was also observed in cases where a small amount of contrast agent was shed on the examination table of the CT scanner after vein rupture during contrast injection (figure 3).

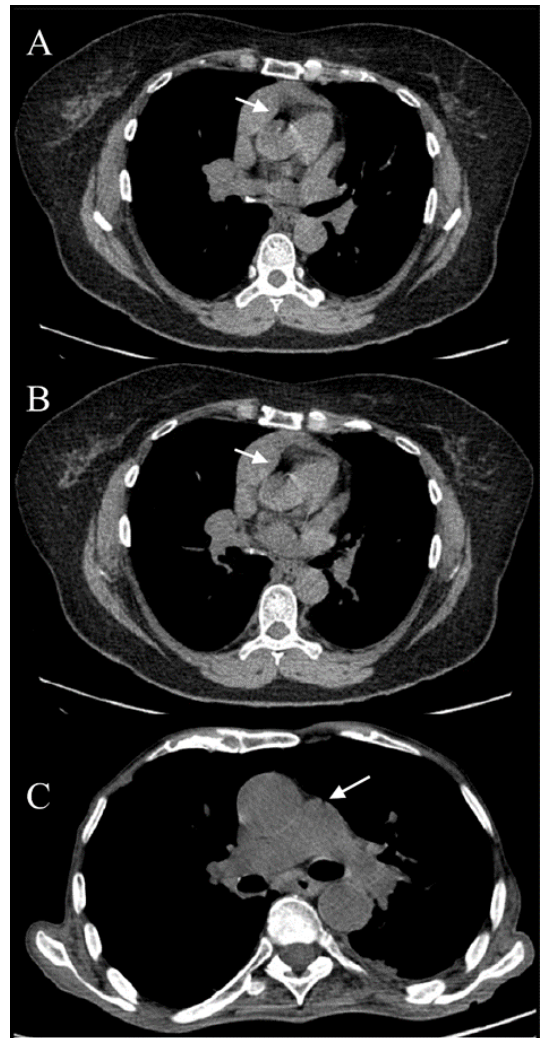
Figure 4. A-C. Axial images of thorax CT without contrast injection. Images (A) and (B) depict an artifact with air density in the cardiac muscle. Image (C) shows a small artifact with air density on the top of the pulmonary vessels. These artifacts may occur due to respiratory movements during scanning.

However, these artifacts are not commonly described in the literature despite their frequent appearance as air existence. In the present study, those artifacts were observed not only in cases involving contrast injection, but also in simple scans where no contrast was used. In those contrast agent-free scans, artifacts were caused by respiratory movements (figure 4).

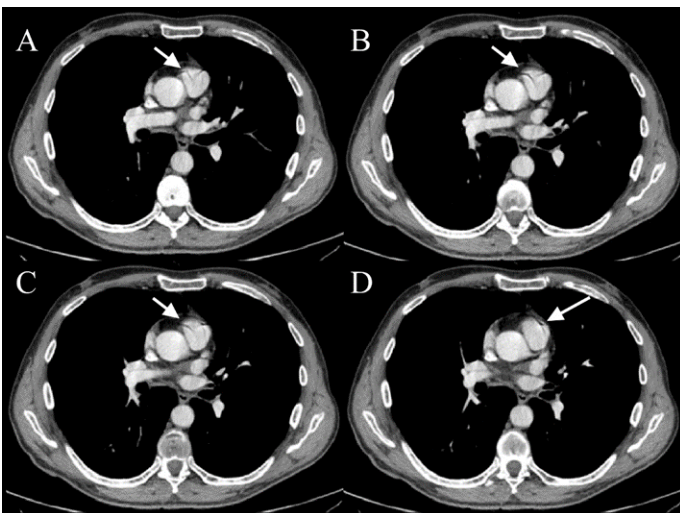
Figure 5. A-D. Axial consecutive images of thorax CT, which illustrate artifacts with air densities in the middle of the pulmonary vessels with the shape of undefined lines and they may be due to the existence of contrast agent on the examination table of the CT scanner.

Normally, every amount of air accumulates in the upper part of the anatomic structures. However, in this study, in some cases those artifacts appeared in the middle or lower sections of vessels in the form of lines and other long shapes. These findings indicate that those artifacts were not caused by the existence of air but instead due to the existence of an amount of contrast agent on the examination table of the CT scanner (figure 5).
