## Thorax artifacts in CT – air embolism or other causes?

Int. J. Radiat. Res., July 2021;  
19(3): 653-659

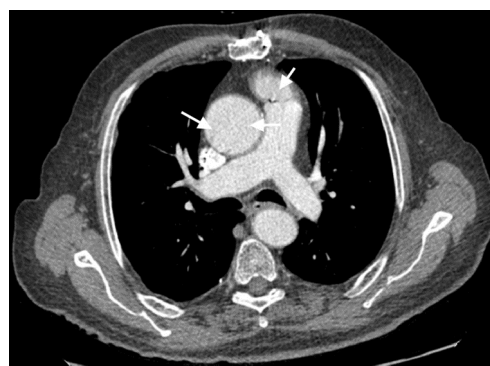
**Figure 1.** Axial image of thorax CT with contrast agent, which demonstrates an artifact with air density in the pulmonary trunk that imitates vessel rupture. This may have occurred from a false response of the reference detectors due to the existence of a small amount of contrast agent on the examination table of the CT scanner (upper right arrow). In addition, a streak artifact is present in the ascending aorta from the high contrast density in the adjacent superior vena cava.

More specifically, figure 1 illustrates an artifact with air density in the pulmonary trunk that imitates vessel rupture and a streak artifact in the ascending aorta from the high contrast density in the adjacent superior vena cava. Figure 2 shows a streak artifact caused by the wall calcifications of the ascending thoracic aorta. In figure 3, an artifact with air density in the pulmonary trunk is presented. In this case, the body of the patient was not entirely in the FOV. Figure 4 illustrate four artifacts with air density (in the cardiac muscle and on the top of the pulmonary vessels), which occurred in a case that no contrast agent was used. Finally, figure 4 demonstrates artifacts with air densities in the middle of the pulmonary vessels with the shape of undefined lines.

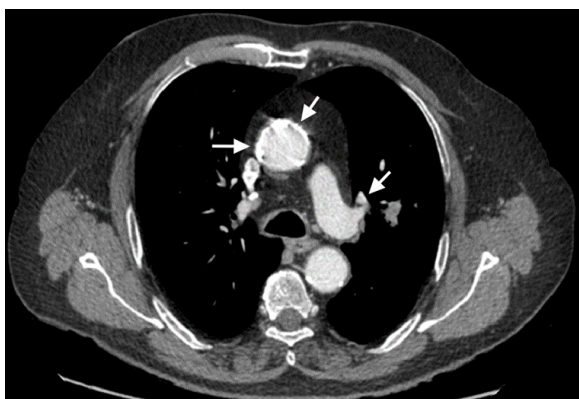
**Figure 2.** Axial image of thorax CT with contrast agent, which shows a streak artifact caused by the wall calcifications of the ascending thoracic aorta.

The present study proves that the causes of all the aforementioned artifacts are numerous. In fact, their most frequent form are streak artifacts. Although, the most common cause of those artifacts is the existence of metallic implants in the patient, there are other reasons too. For example, sometimes contrast agent may have so high density that mimics metal, so it creates streak artifacts especially near superior vena cava (figure 1) (7, 10-12, 14, 22-24). Also, more rarely, even wall calcifications of the thoracic vessels could mimic metal densities and create streak artifacts (figure 2).

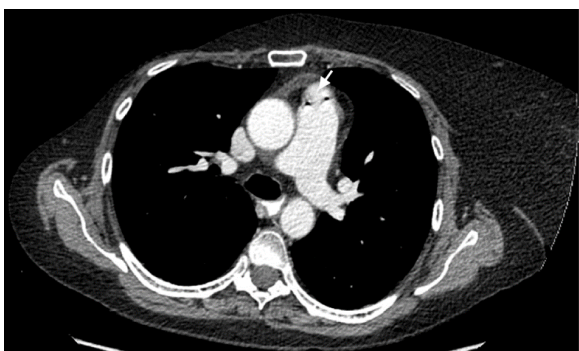
**Figure 3.** Axial image of thorax CT with contrast agent of an overweight patient, which indicates an artifact with air density in the pulmonary trunk (not in the highest level). The body of the patient was not entirely in the FOV and the artifact may have been caused by a fault of the reference detectors.

or in overweight patients where the FOV is not large enough to cover the entire part of the body. In those cases, the reference detectors measure incorrectly and produce artifacts. Further, this artifact was also observed in cases where a small amount of contrast agent was shed on the examination table of the CT scanner after vein rupture during contrast injection (figure 3).

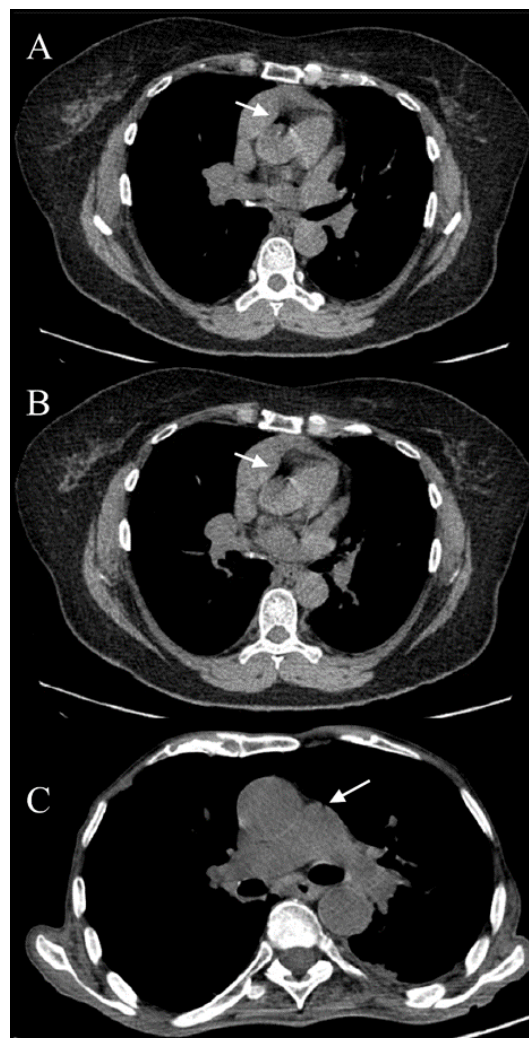
**Figure 4. A-C.** Axial images of thorax CT without contrast injection. Images (A) and (B) depict an artifact with air density in the cardiac muscle. Image (C) shows a small artifact with air density on the top of the pulmonary vessels. These artifacts may occur due to respiratory movements during scanning.

However, these artifacts are not commonly described in the literature despite their frequent appearance as air existence. In the present study, those artifacts were observed not only in cases involving contrast injection, but also in simple scans where no contrast was used. In those contrast agent-free scans, artifacts were caused by respiratory movements (figure 4).

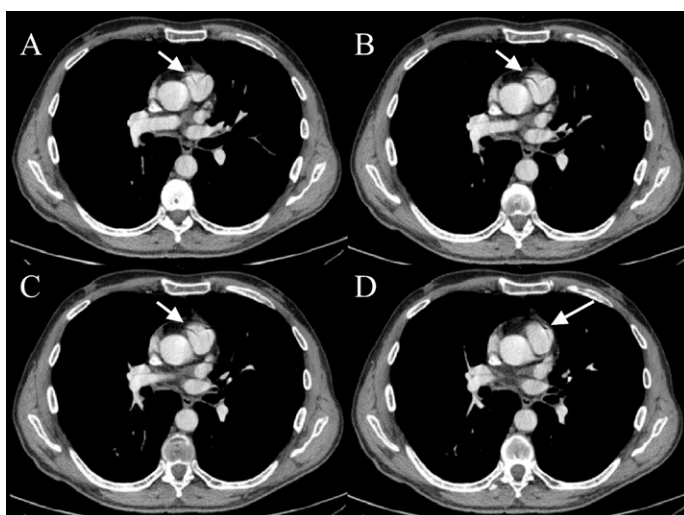
**Figure 5. A-D.** Axial consecutive images of thorax CT, which illustrate artifacts with air densities in the middle of the pulmonary vessels with the shape of undefined lines and they may be due to the existence of contrast agent on the examination table of the CT scanner.

Normally, every amount of air accumulates in the upper part of the anatomic structures. However, in this study, in some cases those artifacts appeared in the middle or lower sections of vessels in the form of lines and other long shapes. These findings indicate that those artifacts were not caused by the existence of air but instead due to the existence of an amount of contrast agent on the examination table of the CT scanner (figure 5).
