Thorax artifacts in CT – air embolism or other causes?

E. Lavdas^{1,2}, M. Papaioannou², A. Tsikrika³, E. Pappas², G.K. Sakkas⁴, V. Roka⁵, S. Kostopoulos⁶, P. Mavroidis^{7*}

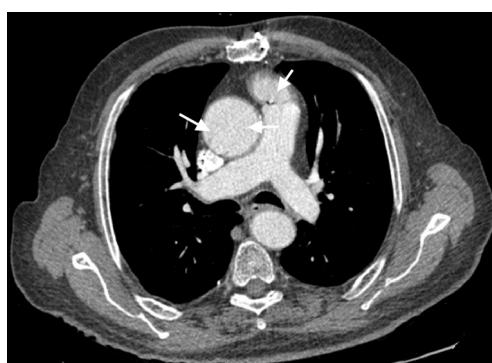
Figure 1. Axial image of thorax CT with contrast agent, which demonstrates an artifact with air density in the pulmonary trunk that imitates vessel rupture. This may have occurred from a false response of the reference detectors due to the existence of a small amount of contrast agent on the examination table of the CT scanner (upper right arrow). In addition, a streak artifact is present in the ascending aorta from the high contrast density in the adjacent superior vena cava.

More specifically, figure 1 illustrates an artifact with air density in the pulmonary trunk that imitates vessel rupture and a streak artifact in the ascending aorta from the high contrast density in the adjacent superior vena cava. Figure 2 shows a streak artifact caused by the wall calcifications of the ascending thoracic aorta. In figure 3, an artifact with air density in the pulmonary trunk is presented. In this case, the body of the patient was not entirely in the FOV. Figure 4 illustrate four artifacts with air density (in the cardiac muscle and on the top of the pulmonary vessels), which occurred in a case that no contrast agent was used. Finally, figure 4 demonstrates artifacts with air densities in the middle of the pulmonary vessels with the shape of undefined lines.

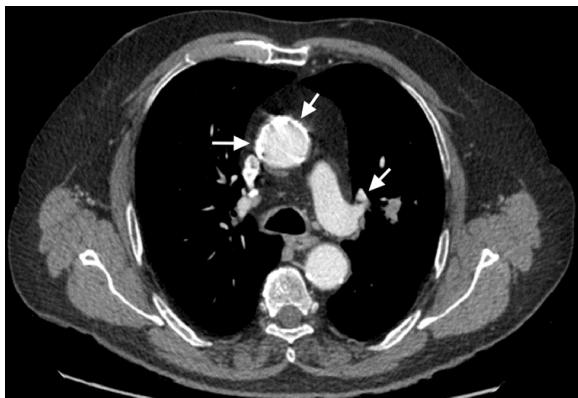
Figure 2. Axial image of thorax CT with contrast agent, which shows a streak artifact caused by the wall calcifications of the ascending thoracic aorta.

The present study proves that the causes of all the aforementioned artifacts are numerous. In fact, their most frequent form are streak artifacts. Although, the most common cause of those artifacts is the existence of metallic implants in the patient, there are other reasons too. For example, sometimes contrast agent may have so high density that mimics metal, so it creates streak artifacts especially near superior vena cava (figure 1) (7, 10–12, 14, 22–24). Also, more rarely, even wall calcifications of the thoracic vessels could mimic metal densities and create streak artifacts (figure 2).

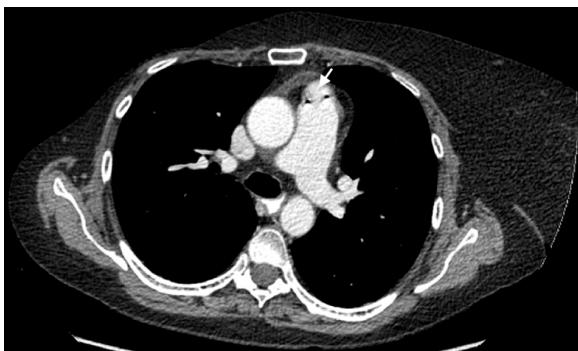
Figure 3. Axial image of thorax CT with contrast agent of an overweighed patient, which indicates an artifact with air density in the pulmonary trunk (not in the highest level). The body of the patient was not entirely in the FOV and the artifact may have been caused by a fault of the reference detectors.

or in overweight patients where the FOV is not large enough to cover the entire part of the body. In those cases, the reference detectors measure incorrectly and produce artifacts. Further, this artifact was also observed in cases where a small amount of contrast agent was shed on the examination table of the CT scanner after vein rupture during contrast injection (figure 3).

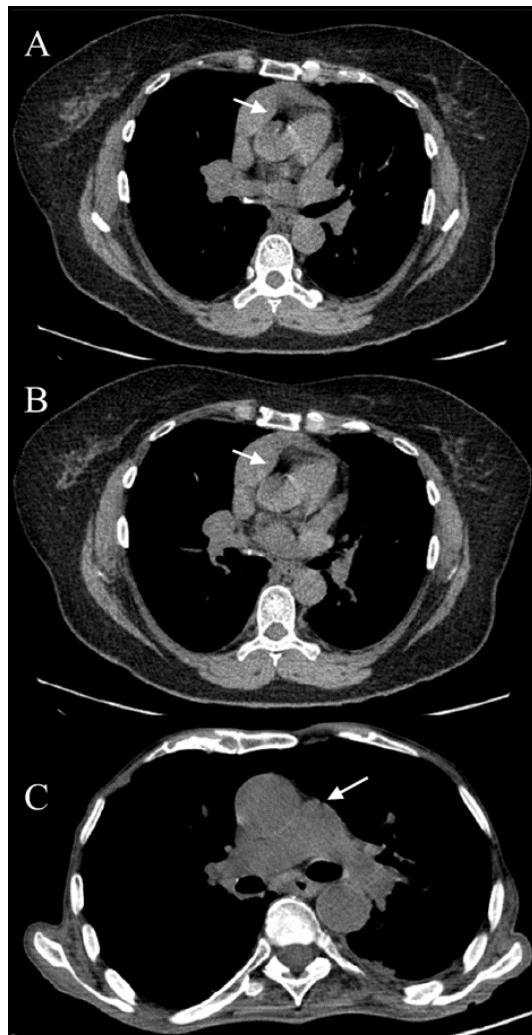
Figure 4. A-C. Axial images of thorax CT without contrast injection. Images (A) and (B) depict an artifact with air density in the cardiac muscle. Image (C) shows a small artifact with air density on the top of the pulmonary vessels. These artifacts may occur due to respiratory movements during scanning.

However, these artifacts are not commonly described in the literature despite their frequent appearance as air existence. In the present study, those artifacts were observed not only in cases involving contrast injection, but also in simple scans where no contrast was used. In those contrast agent-free scans, artifacts were caused by respiratory movements (figure 4).

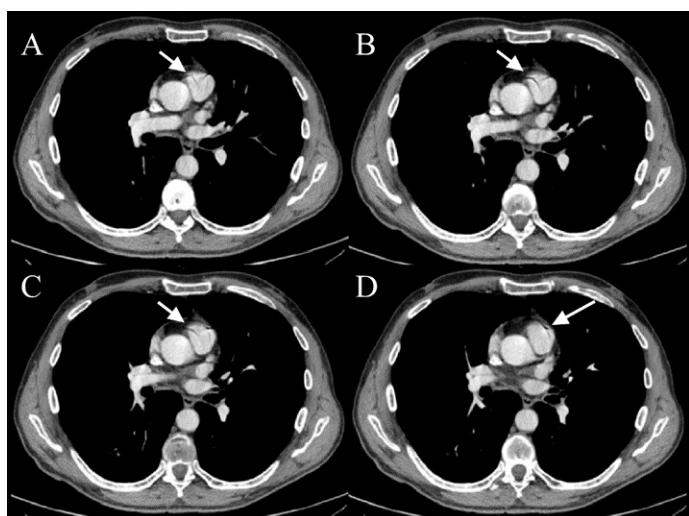
Figure 5. A-D. Axial consecutive images of thorax CT, which illustrate artifacts with air densities in the middle of the pulmonary vessels with the shape of undefined lines and they may be due to the existence of contrast agent on the examination table of the CT scanner.

Normally, every amount of air accumulates in the upper part of the anatomic structures. However, in this study, in some cases those artifacts appeared in the middle or lower sections of vessels in the form of lines and other long shapes. These findings indicate that those artifacts were not caused by the existence of air but instead due to the existence of an amount of contrast agent on the examination table of the CT scanner (figure 5).
